Cross-section Paint Microscopy Report
Interior Paints
Dining Room and Parlor

Eppington
Chesterfield County, VA

Date: February 5, 2007

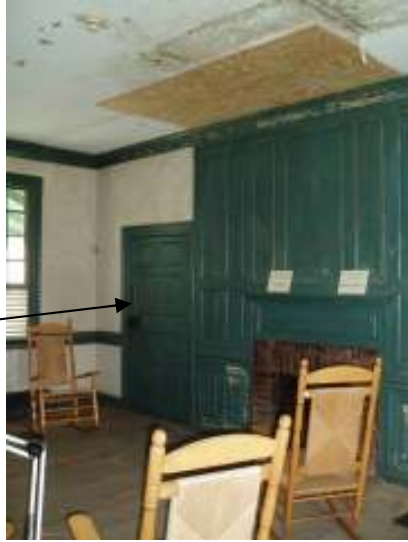
West Chimney Wall

Original opening to the exterior on the west wall

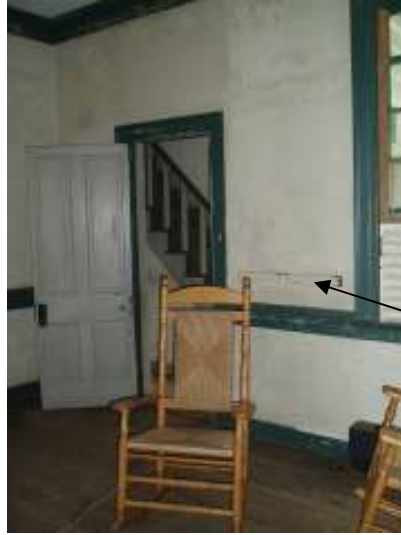
South Wall

Original board on plaster wall

Interestingly, comparisons of the paint evidence on the applied board on the south wall (sample 19), with the other original woodwork, confirms that the first generation of bright green verdigris-based paint was also used on this board. This shows that the board is original to the room and may have been used to support a large frame or a mirror. The paint history on one window muntin (sample 18) is missing all the early green paint layers, but it is notoriously difficult to obtain intact samples from window sashes as they are subject to movement, condensation, reglazing and reputtying, all of which compromises the paint evidence.

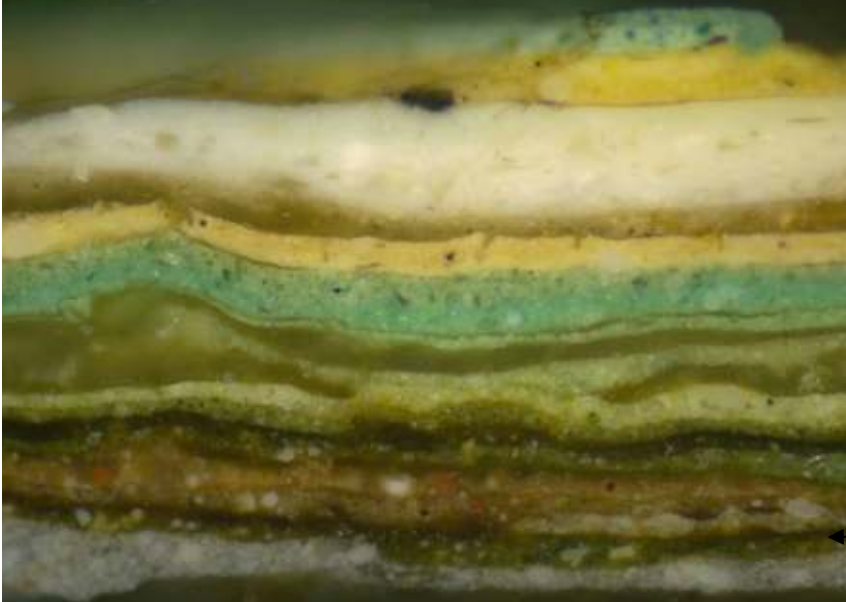
Sample 13. Dining Room. East wall, left architrave for door to hall, about 5-feet up.
Complete woodwork paint chronology
Visible Light 100X

Dining Room Woodwork. The most intact woodwork cross-section (sample 13 from the stair hall door architrave) contains approximately 16 generations of paint. The woodwork paint color sequences begin with a verdigris-based green paint on a gray primer which would have produced a glossy green woodwork color. This is a typical period practice – verdigris is a translucent pigment so verdigris-based green glazes and finish coats were almost always applied on top of green, gray or blue base coats to enhance the green color of the finish coat. The subsequent two generations are tannish-yellow, followed by three more verdigris-based green paints. In generation 11 the room was painted medium blue-green, which is similar to the current room color.

Original verdigris-based finish coat on gray primer

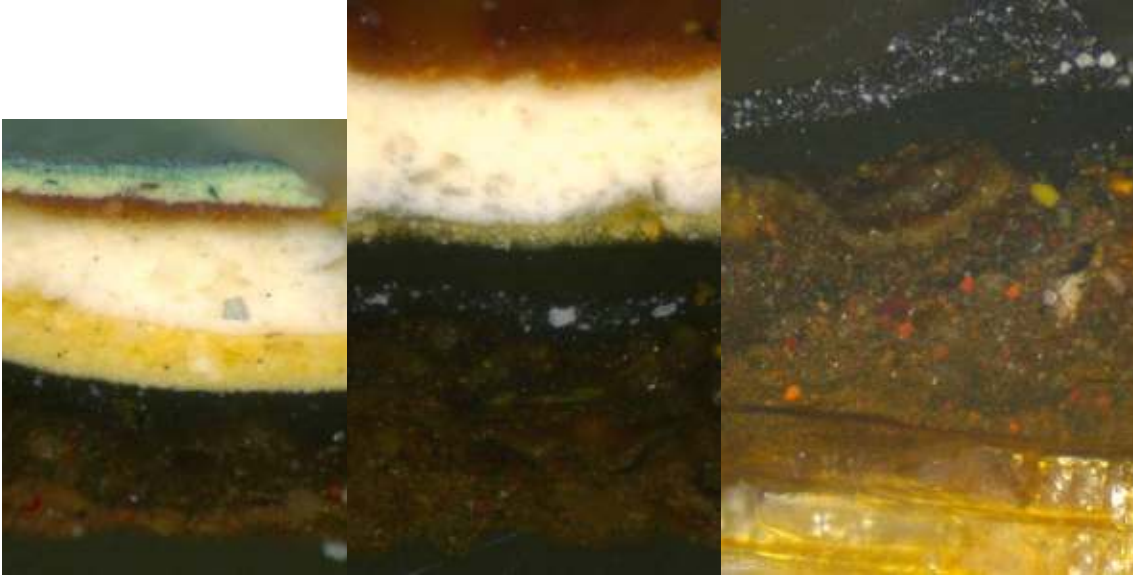
Dining Room Door Paint Comparison

The original paint layer on the earliest doors in the room (sample 7 from the closet side of the door to the south of the fireplace and sample 15 from the east wall door leading to the stair hall) is a coarsely ground deep red-brown paint. The closet door on the west wall was turned around but is in a Period I exterior opening. The evidence in samples 6 and 7 from this door show that the side now facing the room was originally the exterior surface because of the evidence of weathering. The same deep red-brown paint layer was found in sample 5, from the door in the northwest corner of the west wall, which is a Period IV installation, but it may have been moved from another area of the house because it retains the earliest red-brown paint layer, as well as the later pigmented varnishes.

First deep red-brown paint layer found in all three samples

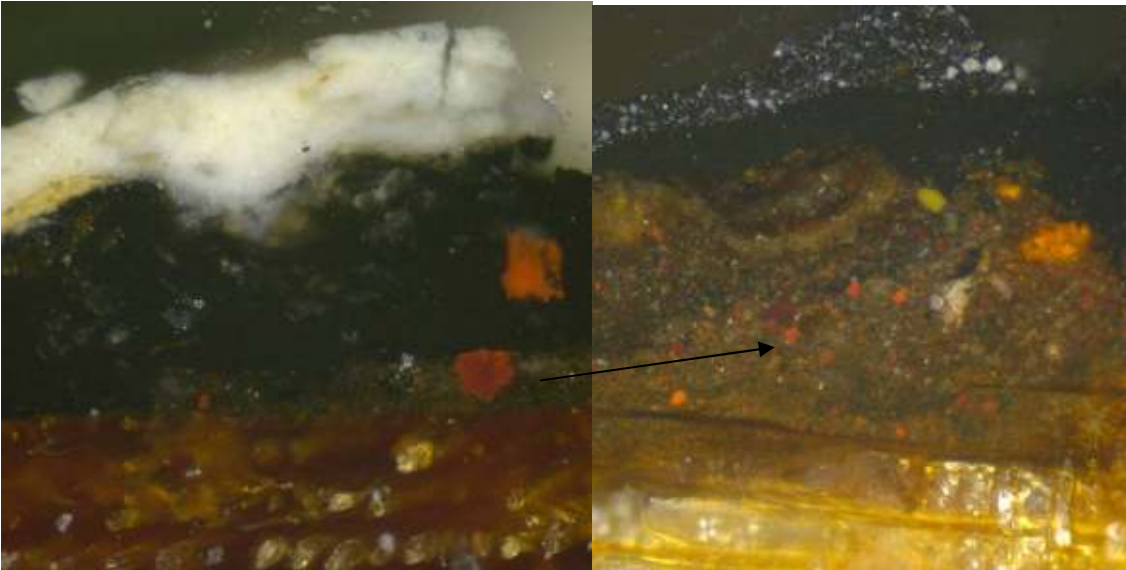
Baseboard sample compared to stair hall door sample

The early baseboard paints can be aligned with the door paints, so the baseboards in the Dining Room were originally deep red brown, followed by several pigmented shellac layers, and then they were painted dark gray, like the doors, in generation 6.

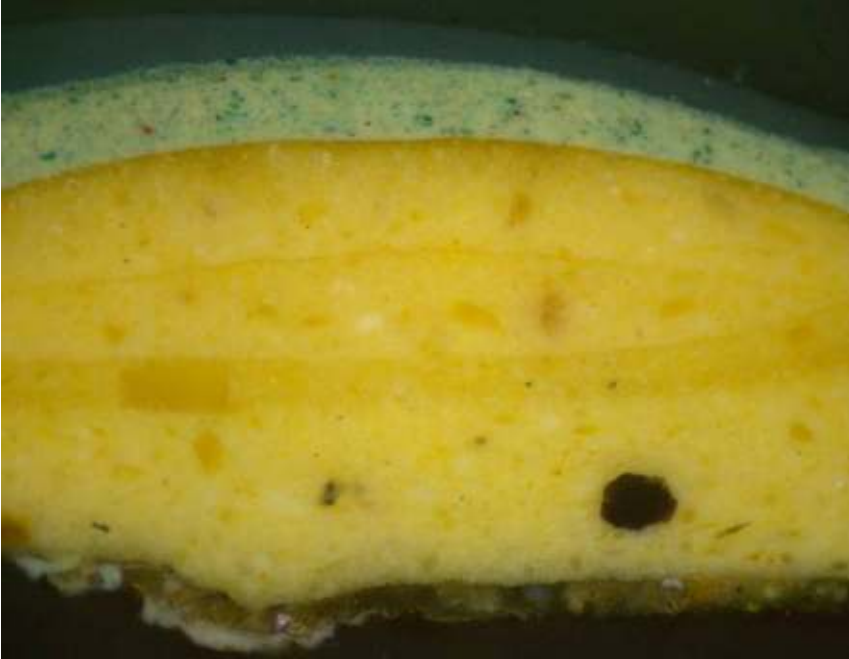
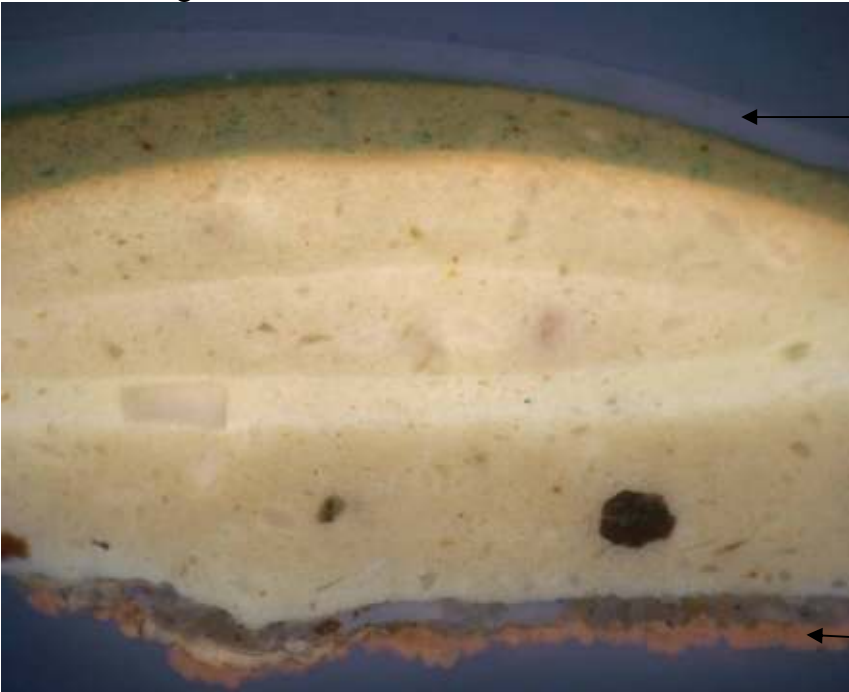
Sample 1. Dining Room. West wall, fireplace wall, leading edge of mantel shelf, about 3-inches from right corner.

The stratigraphy on the mantel shelf (sample 1) begins with a much later shellac layer, followed by yellow paint. This sample may be incomplete because it was from a relatively exposed location. It is more likely that the mantel shelf was painted with the same early greens to match the paneling, similar to the treatment of the mantel shelf in the adjacent Drawing Room. The uppermost glossy, clear layer on the surface of most of the samples from the woodwork is a consolidant layer applied by the Chesterfield County maintenance department to help contain the flaking paint and limit the amount of lead paint particles in the air.

Modern sealant layer

Later shellac layer on shelf

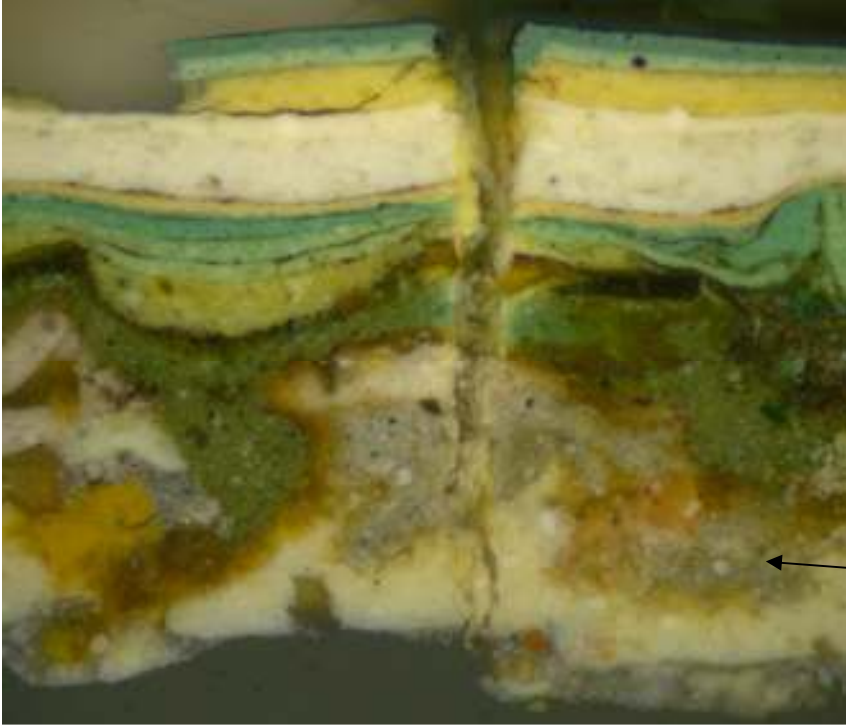
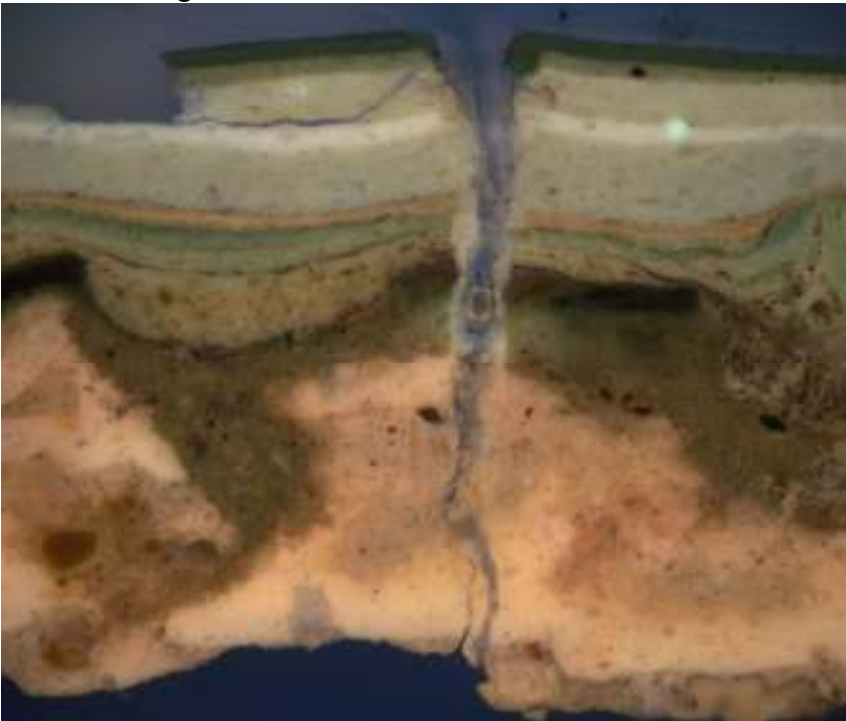
Sample 2. Dining Room. West wall, panel just right of fireplace, at lower edge where quarter-round molding meets chamfered edge of raised panel.

← Early paint layers are disrupted, perhaps due to heat exposure from the fireplace

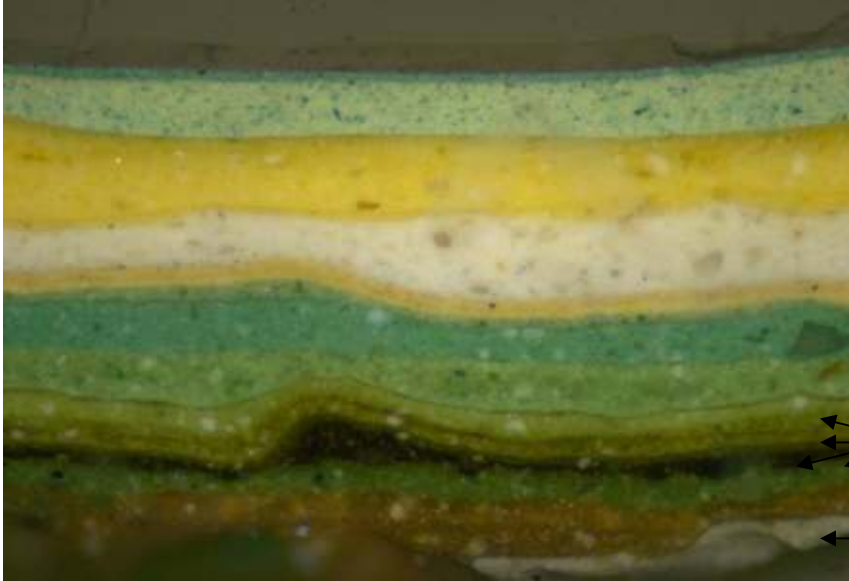
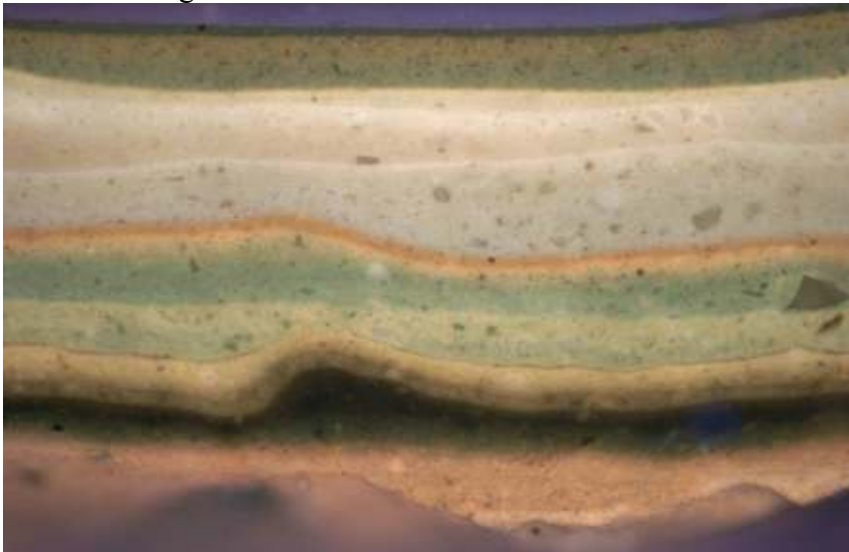
Sample 4. Dining Room. West wall, NW corner, outer band of door architrave, left side, about 4-feet up, at cove molding.

Four more generations of bright green paint begin at generation 4

Original gray primer, but the verdigris-based green finish coat is missing in this sample

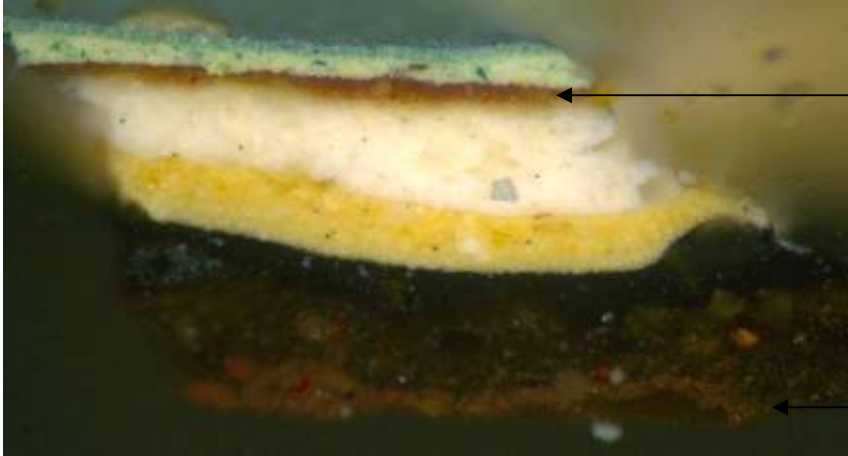
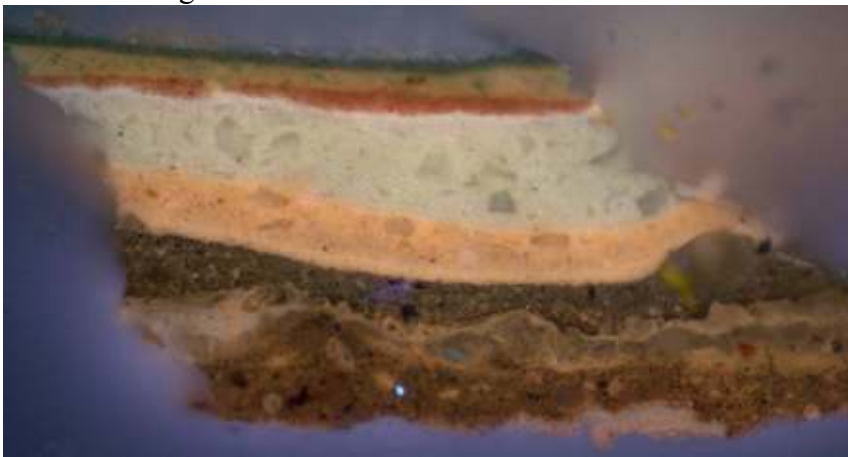
Sample 5. Dining Room. West wall, door in NW corner, upper left corner, lower left panel.

Late grain-painting on the door just before the room was painted blue-green

Paint on later door begins with deep red-brown

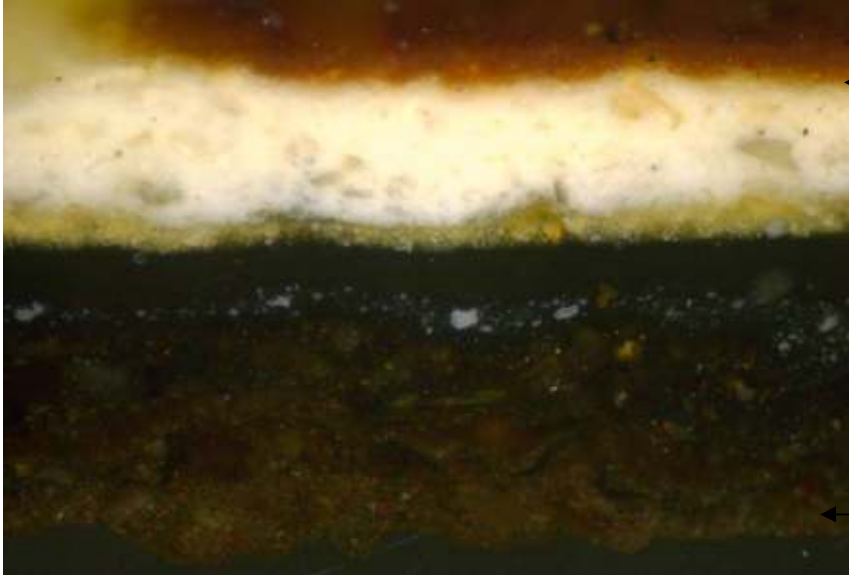
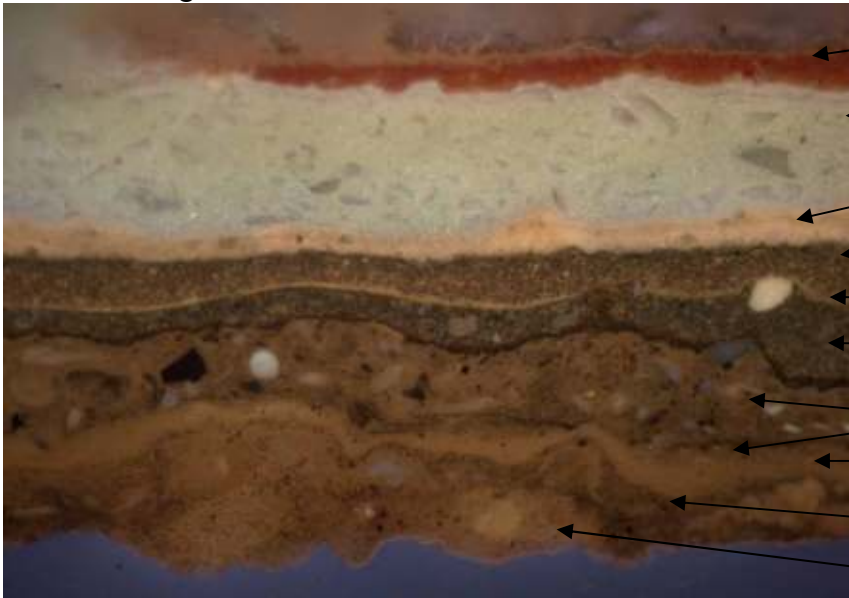
Sample 7. Dining Room. West wall, door left of fireplace, inner closet surface, lower left corner of middle left panel, currently has a dark graining.

← Most recent grain-painting also found in sample 6

← First layer of dark red-brown door paint

← 10. Graining glaze with shellac coating

← 10. Graining base coat

← 9. Yellow

← 8. Pigmented varnish

← 7. Shellac

← 6. Dark gray

← 4. & 5. Pigmented shellac

← 3. Shellac

← 2. Pigmented shellac

← 1. Red-brown paint

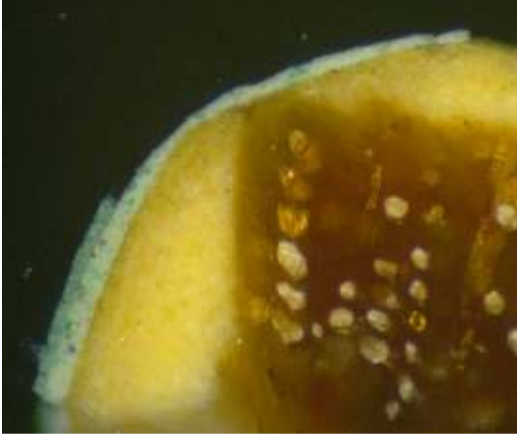
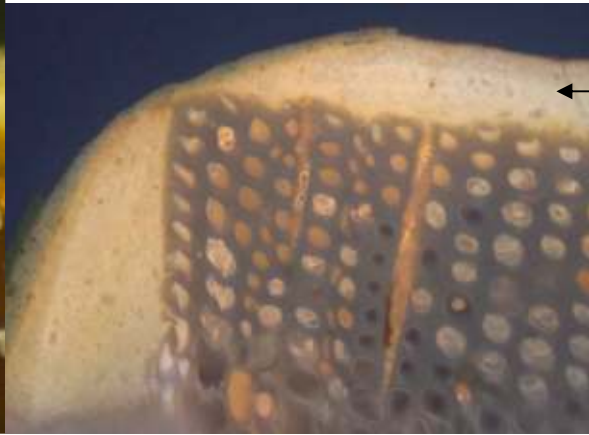
Sample 10. Dining Room. North wall, NW corner, later bookcase, front edge, top shelf, left side.

Generation
14

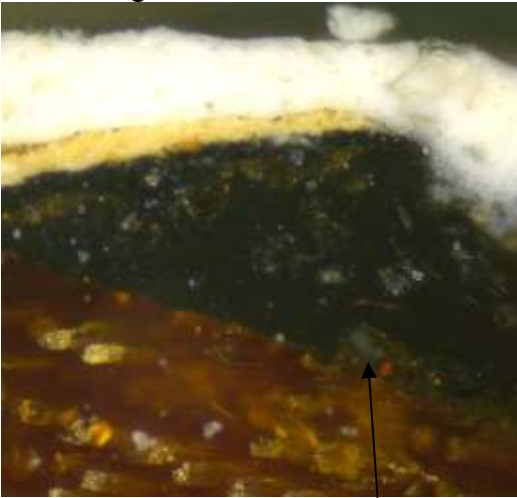
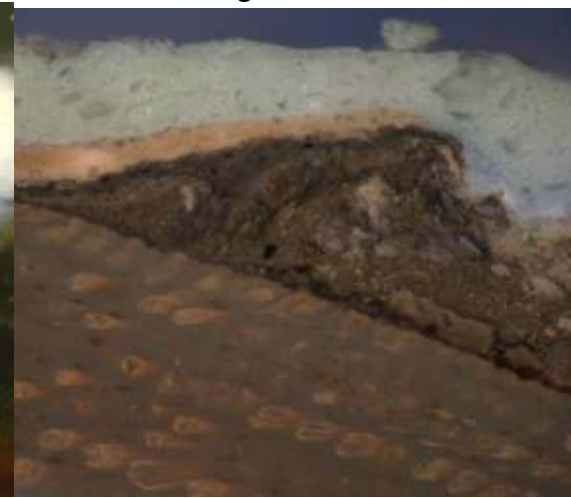
Sample 11. Dining Room. North wall baseboard, 3-feet left of east wall, just below top bead molding.

Original deep red paint

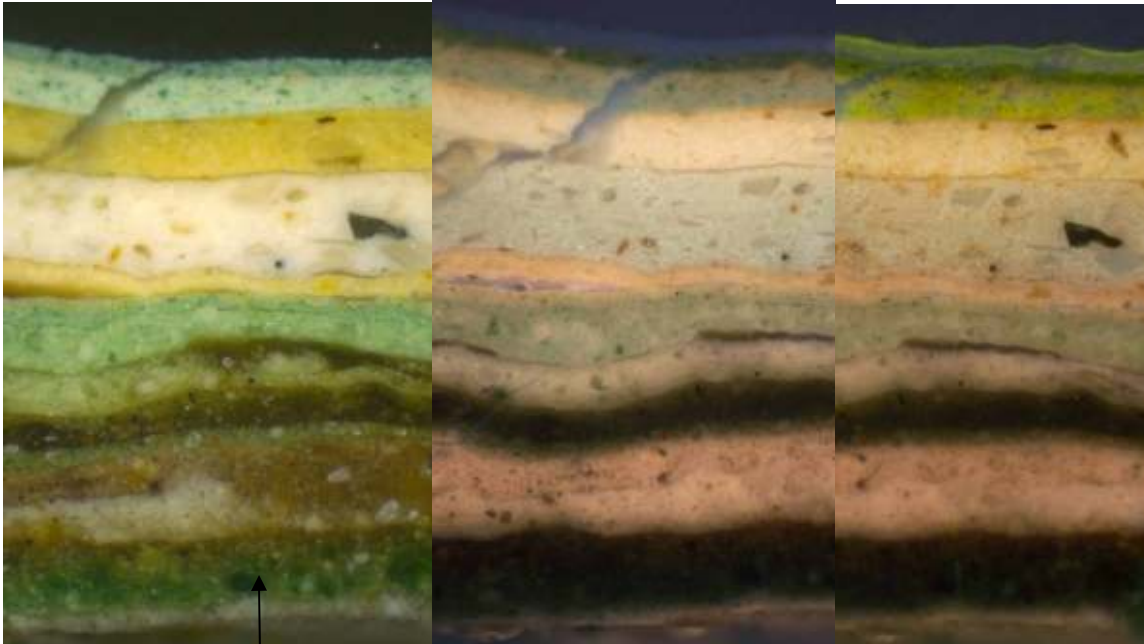
Sample 12. Dining Room. North wall window, right architrave, outer molding about 5-feet up from floor.

Excellent example of intact
original verdigris-based green
paint

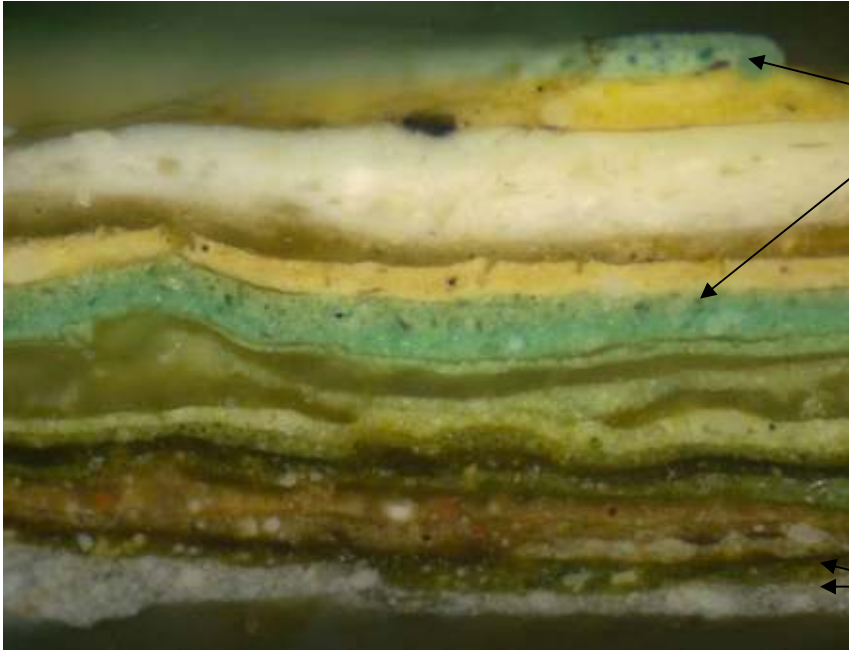
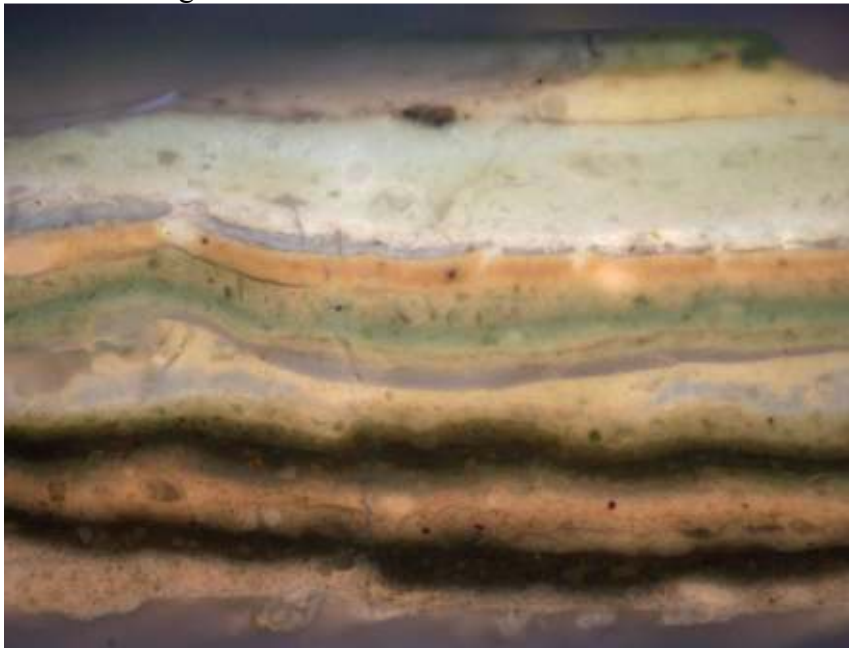
Sample 13. Dining Room. East wall, left architrave for door to hall, about 5-feet up.
Visible Light 100X

The most recent paint color may have been intended to mimic the blue-green paint in generation 11

Original gray primer with bright green finish coating

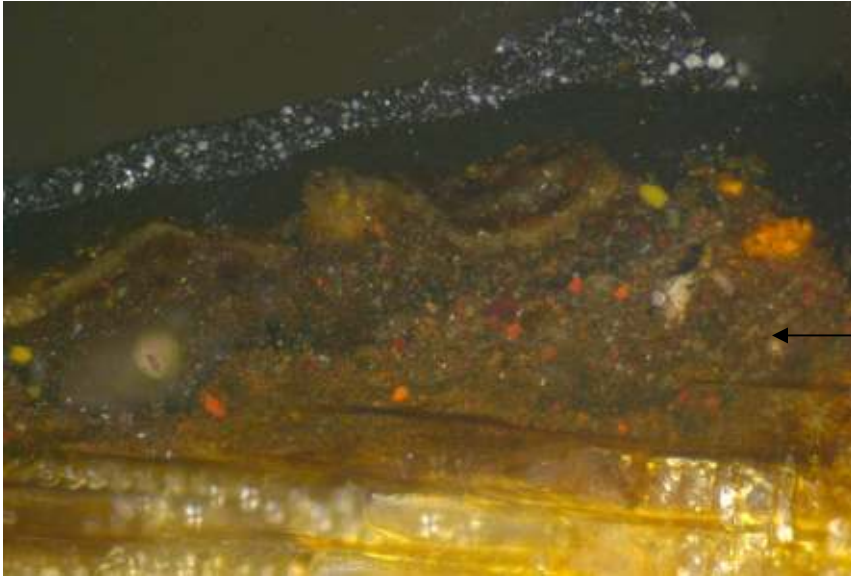
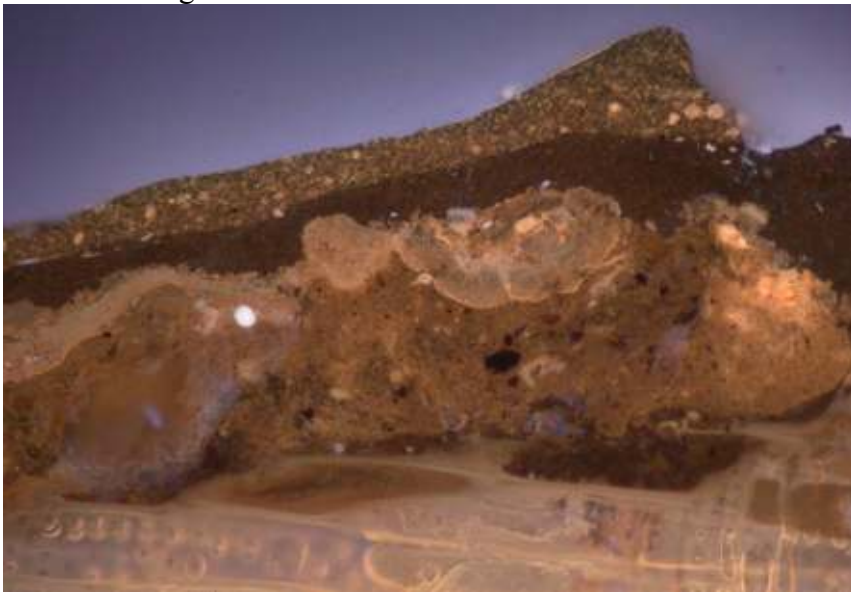
Sample 15. Dining Room. East wall door, upper left corner of middle left panel.
Visible Light 200X

← Earliest red-brown
paint on the original
door to the passage

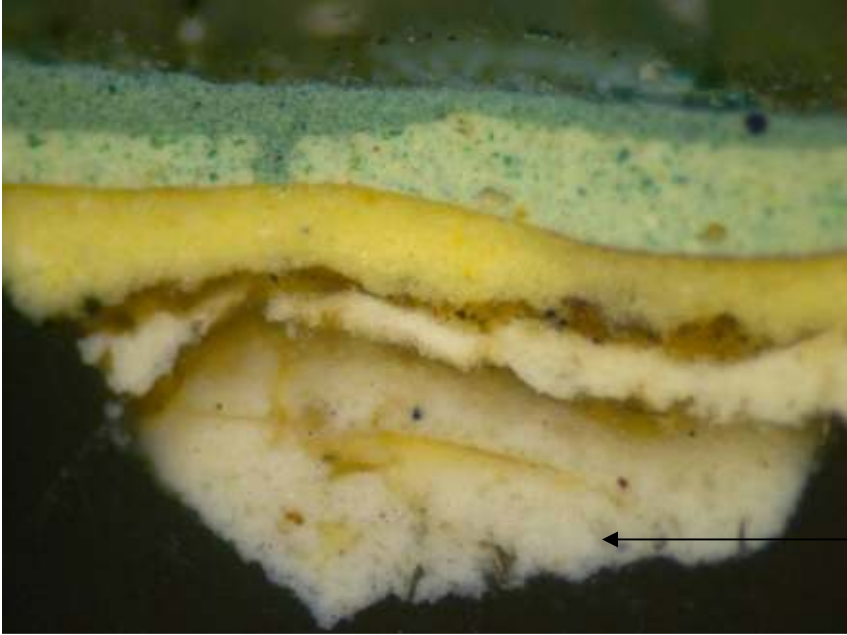
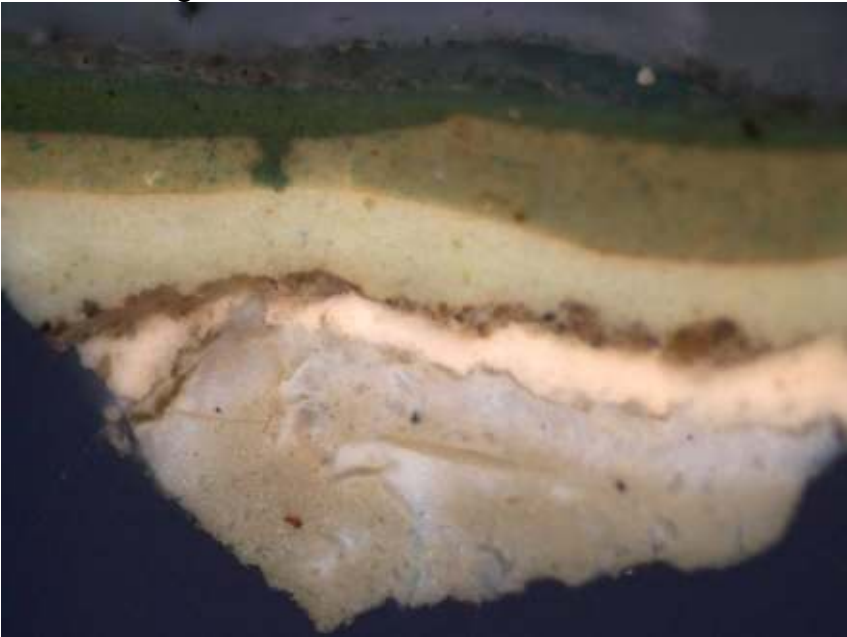
Sample 18. Dining Room. South wall, window muntin, lower right pane, left side.

← Early paints missing from the window muntin

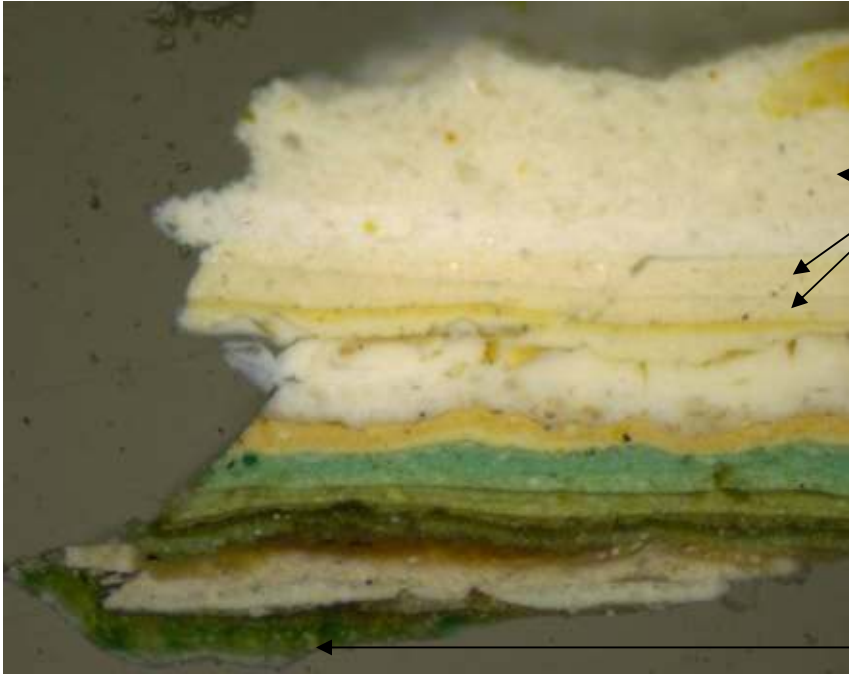
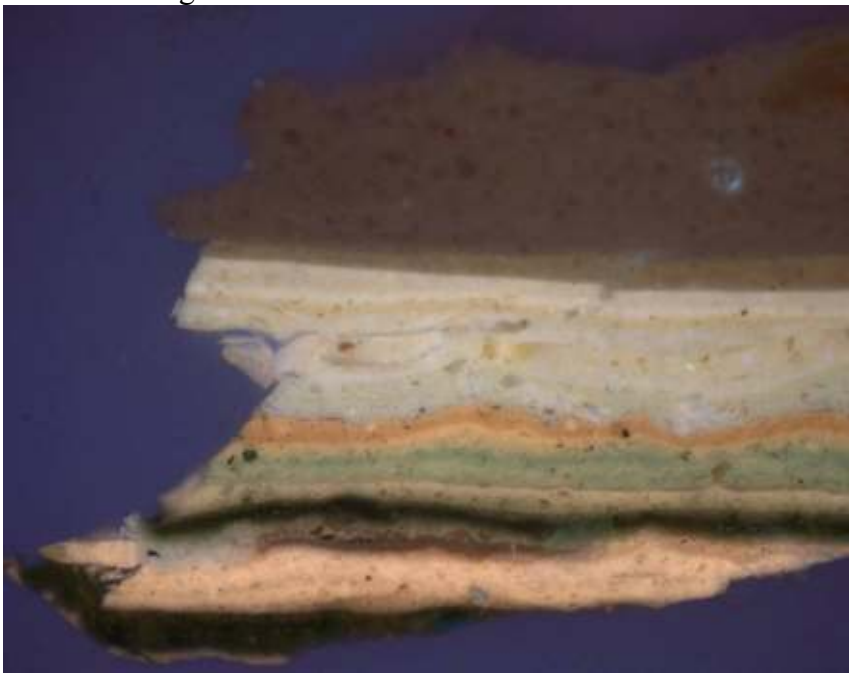
19. Dining Room. South wall, applied board with iron fitting.
Visible Light 100X

Later wall paints
on top of board

Original bright green
verdigris-based paint on
top of a gray primer

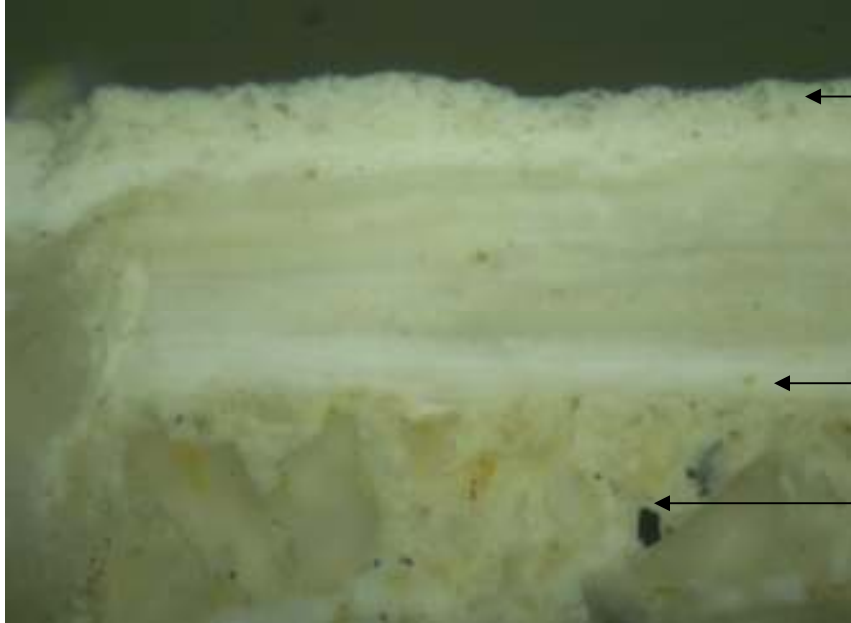
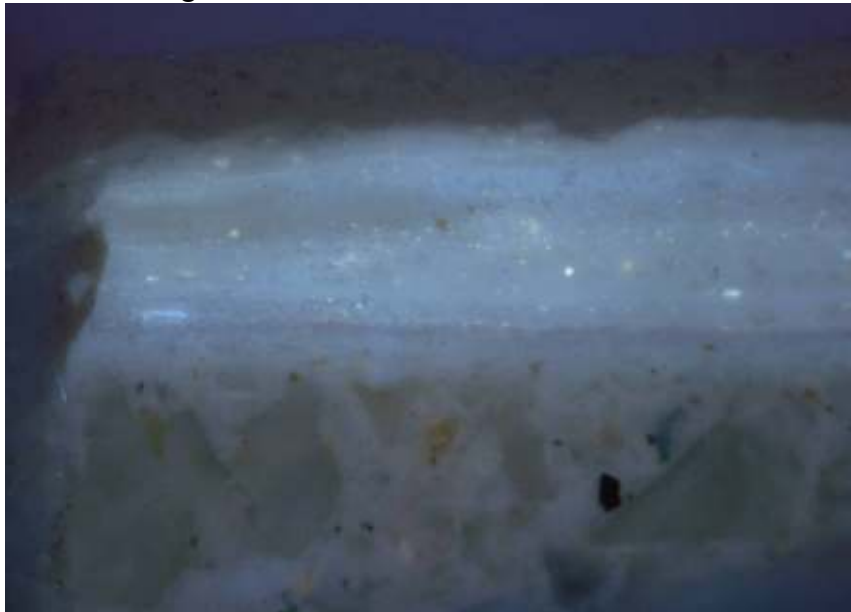
Sample 20. Dining Room. North wall, east of window, at long crack in plaster about 5-feet up from the floor.

Dining Room Plaster. One important wall plaster cross-section (sample 20) shows that the plaster in the Dining Room was originally coated with an unpigmented limewash on top of a sandy white plaster substrate. This was followed by eight more generations of traditional unpigmented limewash on the walls. The most recent thick white paint on the walls was likely applied to simulate limewash. Wenger, Chappell and Graham suggest the plaster was not completed until Period IV, so perhaps the most appropriate paint scheme for interpretation of this room are the Period IV paint layers which would include white limewashed walls, red-brown doors and baseboards and a verdigris-based bright green paint. This is similar to the original Period II paint scheme, except the room may not have been plastered at that point.

← Most recent white wall paint

← First thin unpigmented limewash layer

← Sandy white plaster substrate

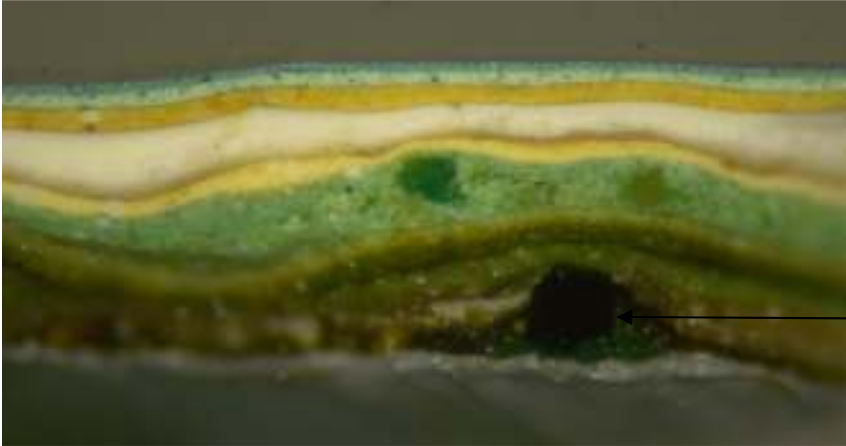
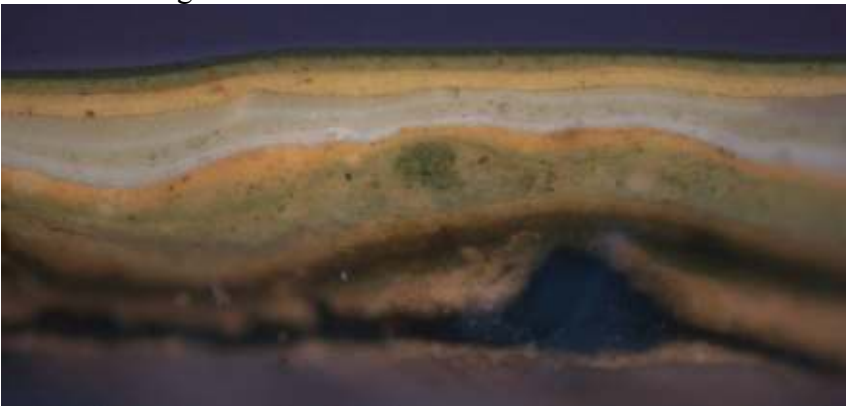
Sample 21. Dining Room. East wall, cornice above door, narrow fillet below uppermost quarter round molding.

Large chunk of
verdigris pigment in
original green paint

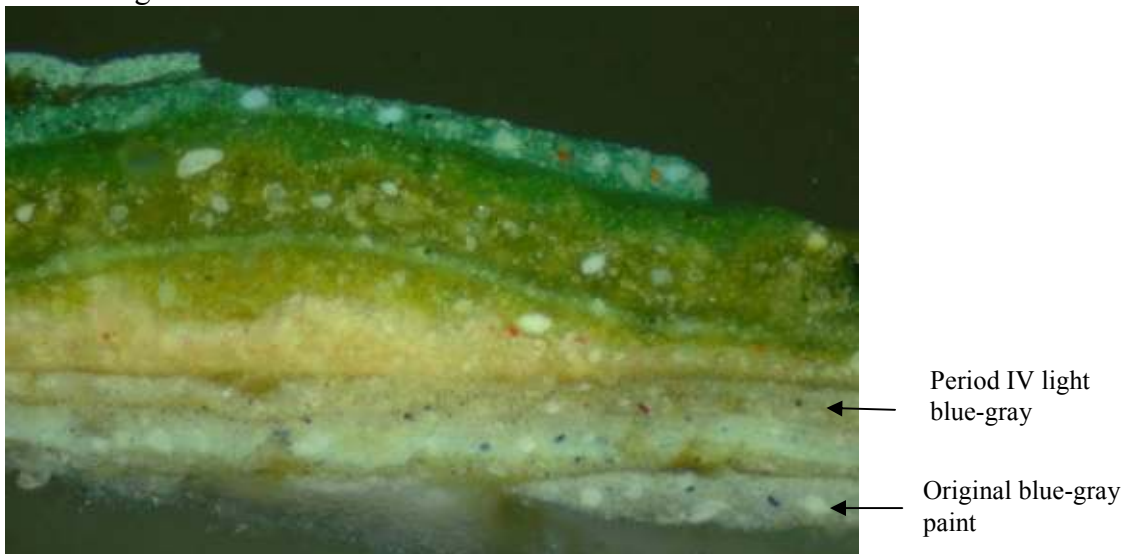
Visible Light 200X

Sample 18. Drawing Room. North wall, architrave for door, left side, just below top of wainscoting.

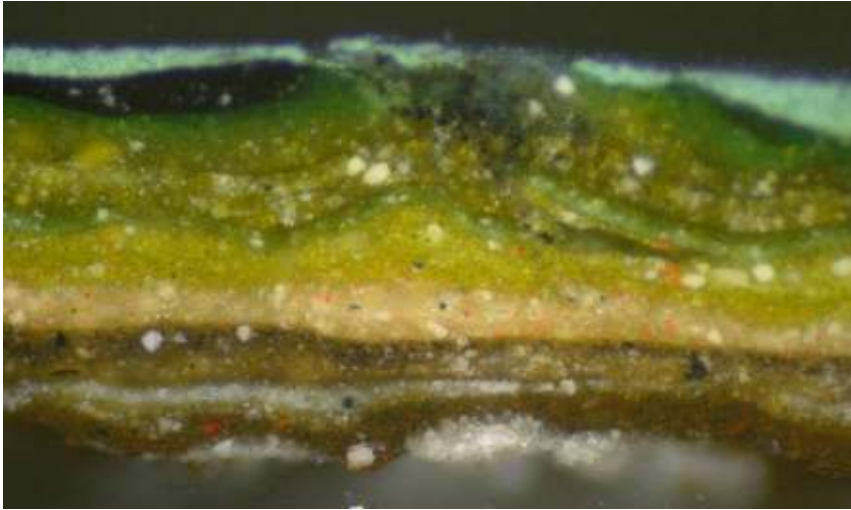
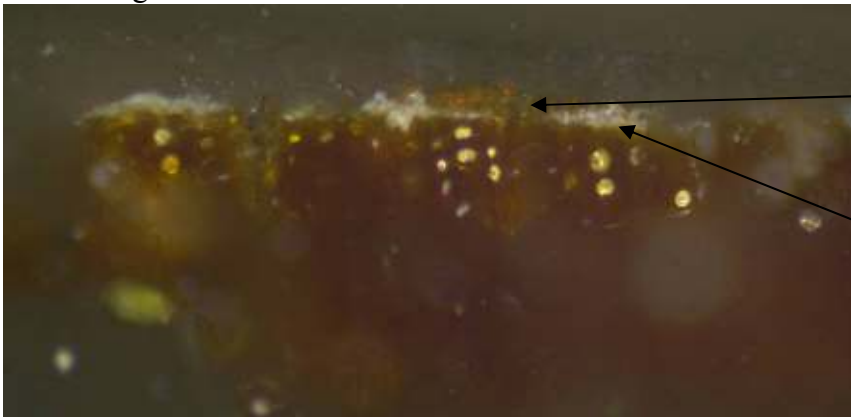
Sample 2. Drawing Room. East wall, leading edge of mantel shelf, right side.
Visible Light 200X Detached paints

Second red-brown
paint on the mantel
shelf

Remnants of first
blue-gray paint

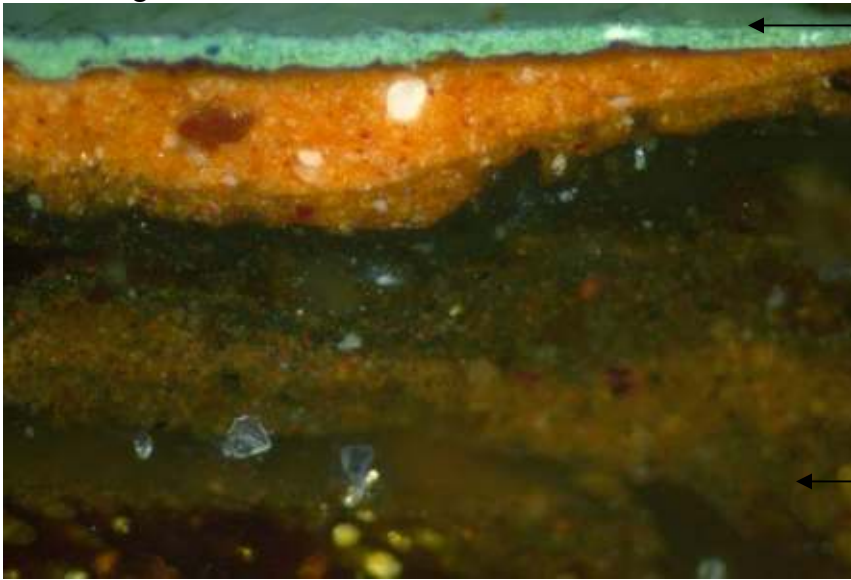
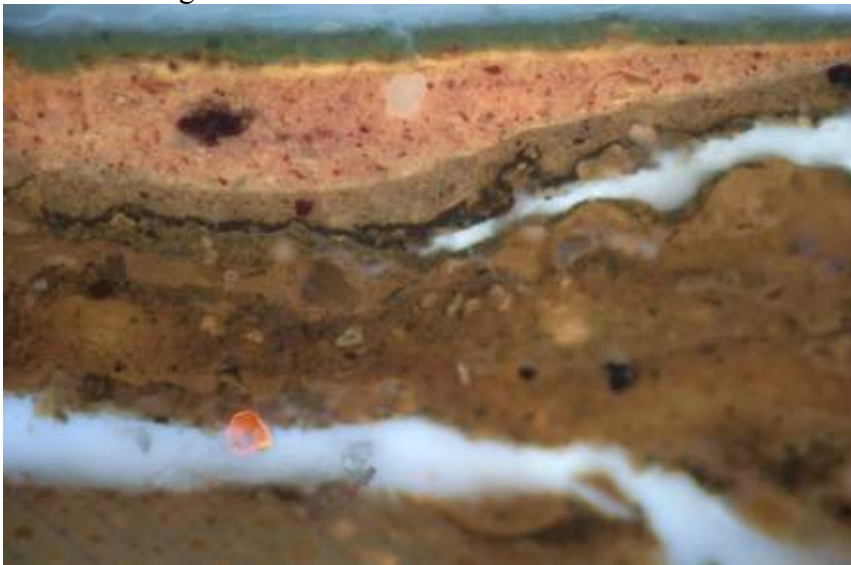
Sample 4. Drawing Room. East wall door, upper left corner of left panel.
Visible Light 100X

Current blue-green paint

First deep brown paint layer

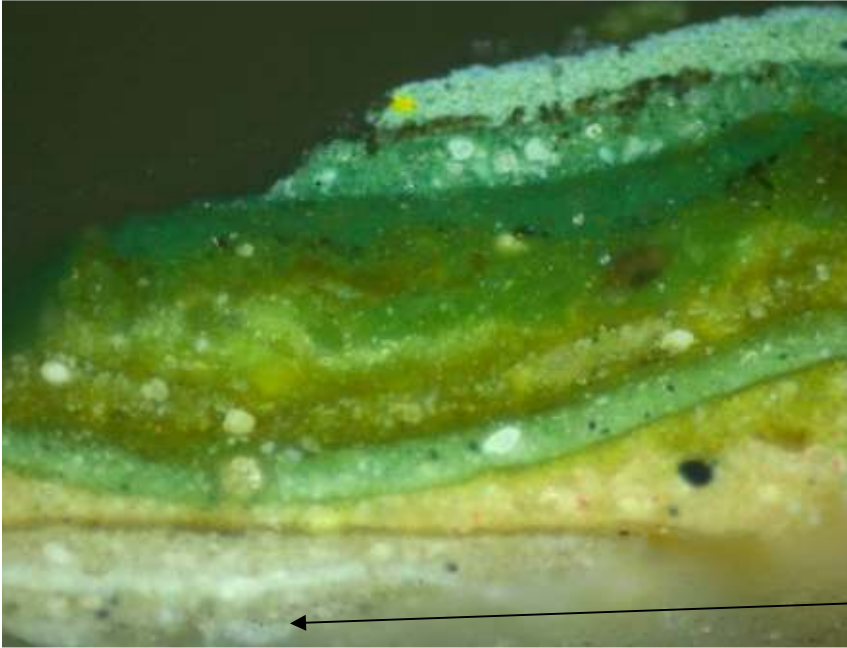
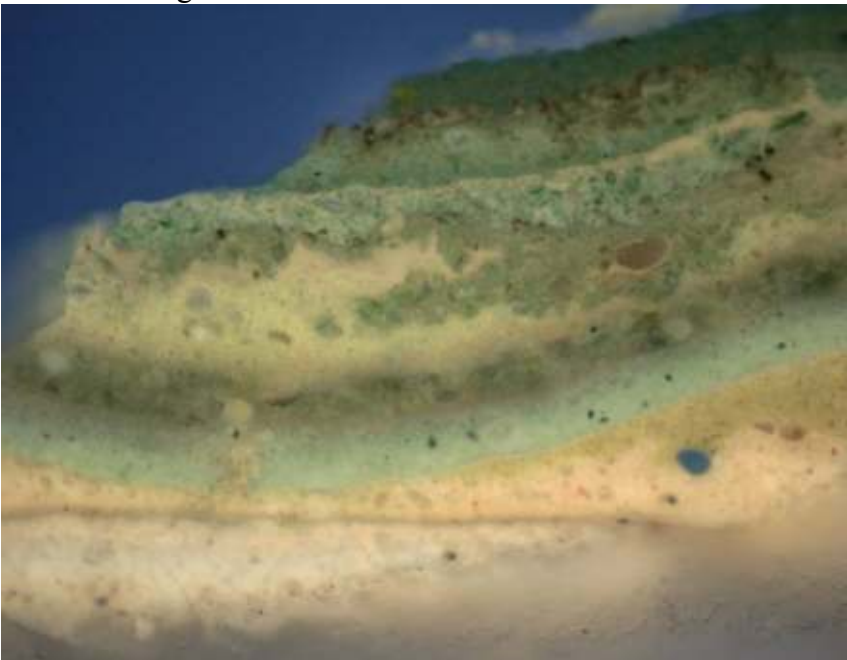
Sample 5. Drawing Room. East wall, left door architrave, about 3-feet up from floor.
Visible Light 200X

First light blue-gray
paint layer

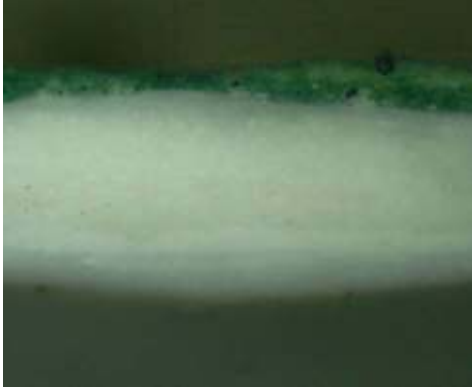
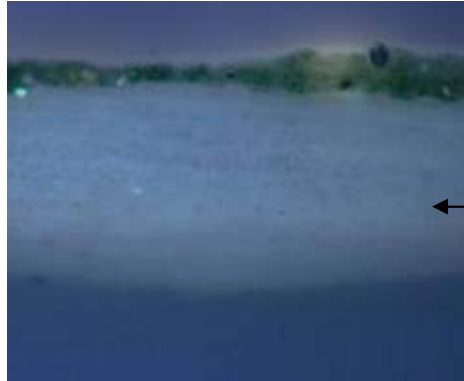
Sample 6. Drawing Room. North wall, NE corner, plaster above wainscot at join of fireplace wall.

Visible Light 100X

Ultraviolet Light 100X

← Approximately 10 generations of unpigmented limewashes

Drawing Room Plaster. Samples taken from different areas of plaster, and from the soffit of the cornice, show that there are up to fifteen generations of unpigmented limewash in some areas, followed by the uppermost opaque blue-green paint now on the walls. The soffit of the cornice (sample 7) was initially coated with at least two of the original blue-gray paints, followed by two generations of limewash, and then a thin deep red layer not found elsewhere in the room. The uppermost four generations of paint – dark gray, light red, off-white, and blue-green) can only be aligned with the woodwork paints in the last blue-green paint layer. This is quite different from the paints on the cornice in the Dining Room which are the same as the paneling paints throughout the paint sequence. Other areas of the cornice should be rechecked before the room is reinterpreted, but the cornice painting does follow the pattern of matching the woodwork paint color for at least the first two paint generations. One sample from the ceiling plaster (sample 8) shows that there are approximately fifteen generations of unpigmented limewash on the ceiling as well as the walls.

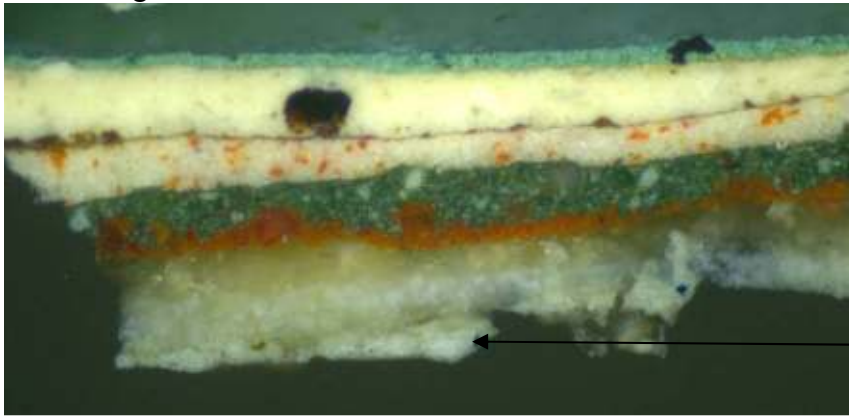
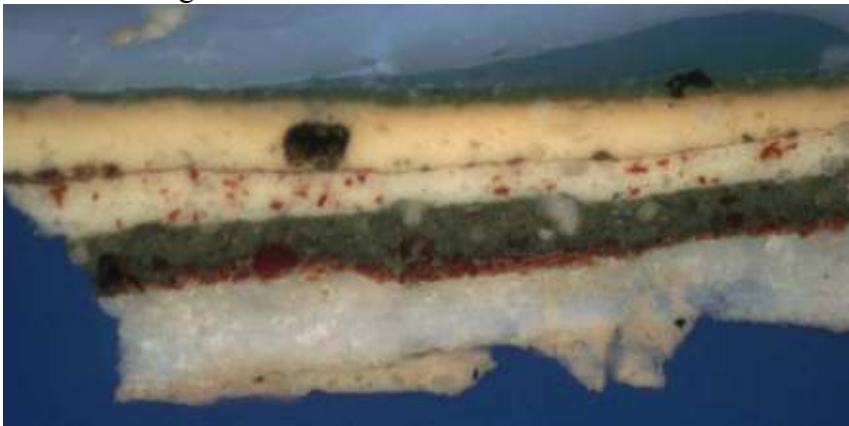
Sample 7. Drawing Room. East wall, soffit of cornice in SE corner.

← Remnant of first blue-gray paint
