Cross-section Paint Microscopy Report
Interior Paints
Dining Room and Parlor

Eppington
Chesterfield County, VA

Date: February 5, 2007

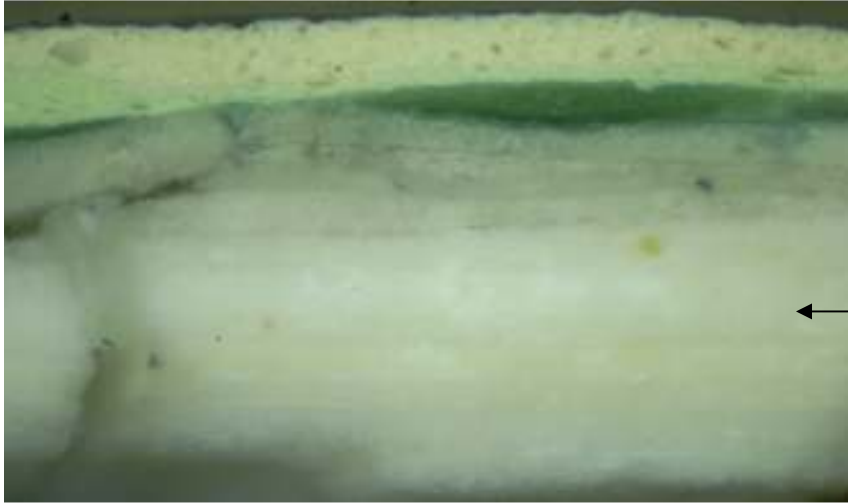
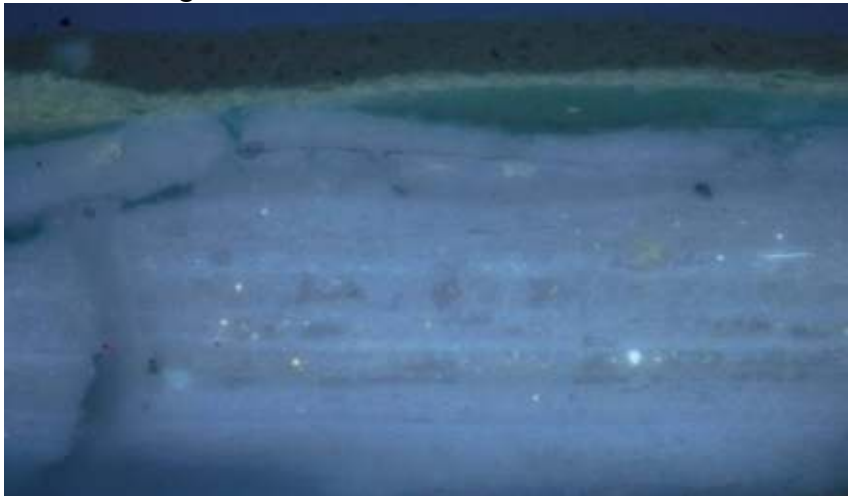
Sample 8. Drawing Room. SE corner, ceiling plaster, multiple limewashes.
Visible Light 100X

Long sequence of unpigmented limewashes

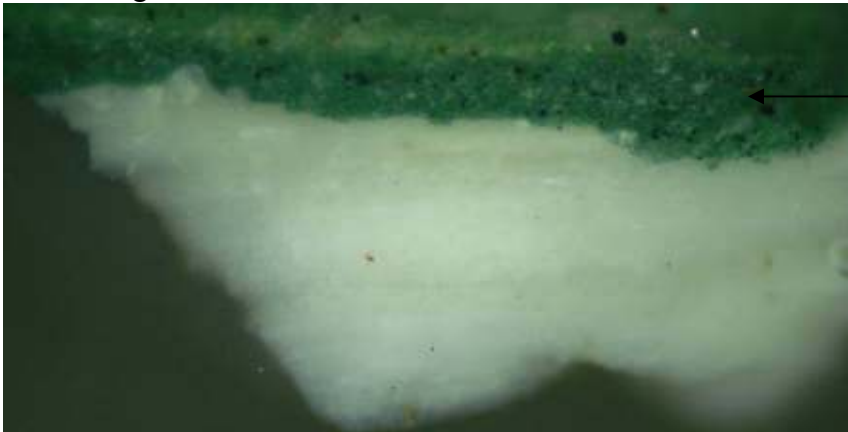
Sample 9. Drawing Room. SE corner, plaster wall at crack, directly above chair board.
Visible Light 100X

Current blue-green wall paint above at least 13 generations of unpigmented limewash

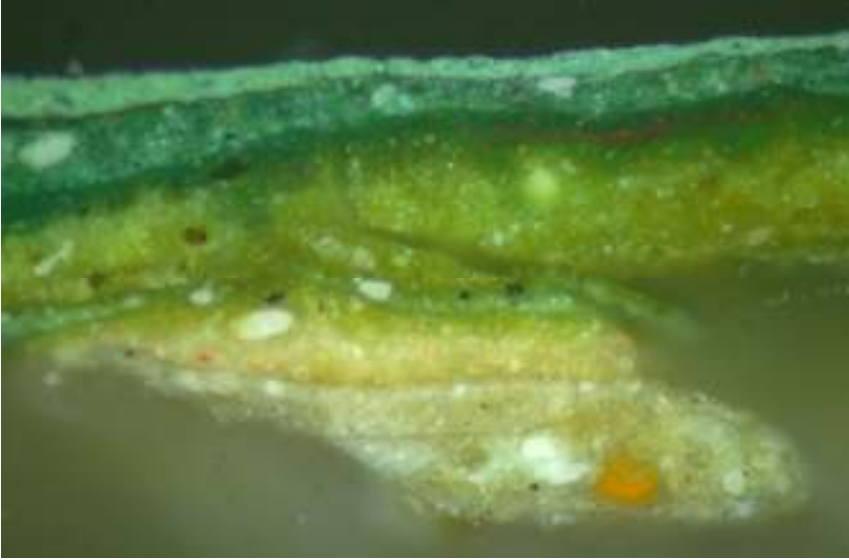
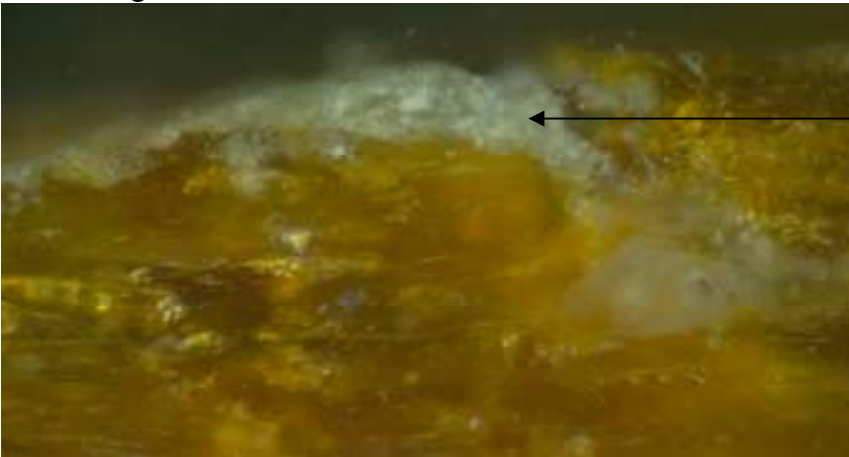
Sample 10. Drawing Room. South wall, east window, west architrave, about 1-foot above sill.

Original blue-gray
paint on the wood
substrate

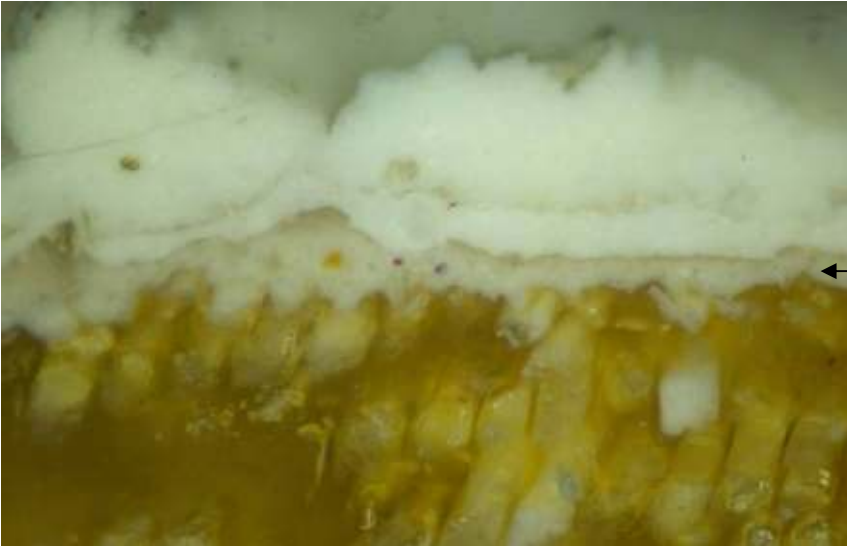
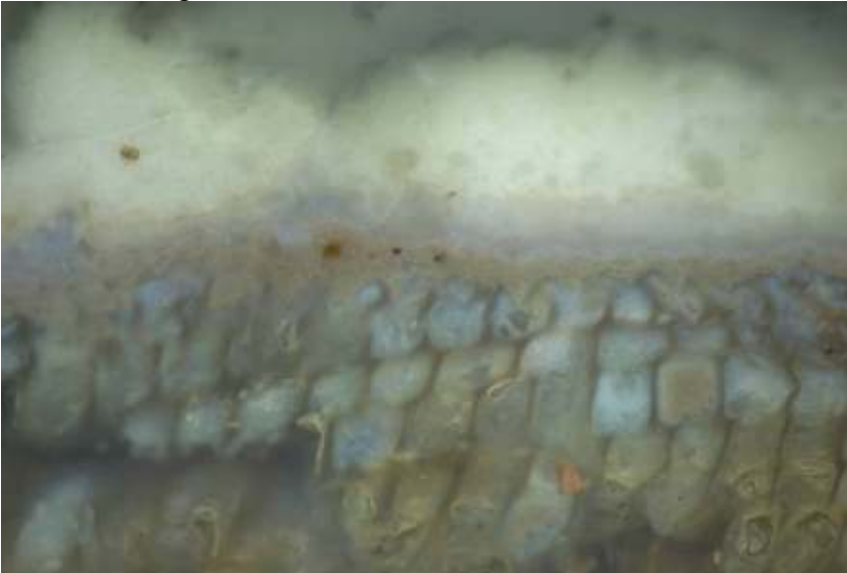
Sample 11. Drawing Room. South wall, east window, sash.
Visible Light 200X

← Only later paints on the sash

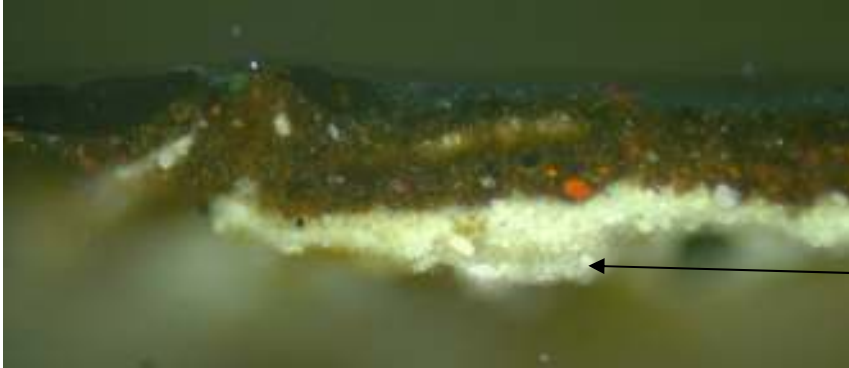
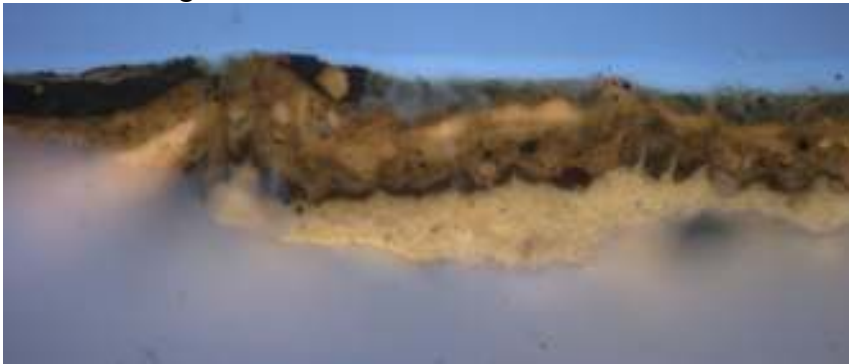
Sample 12. Drawing Room. South wall, top of molding of wainscoting, between two windows, about 6-inches left of west window.

← Remnant of first blue-gray paint

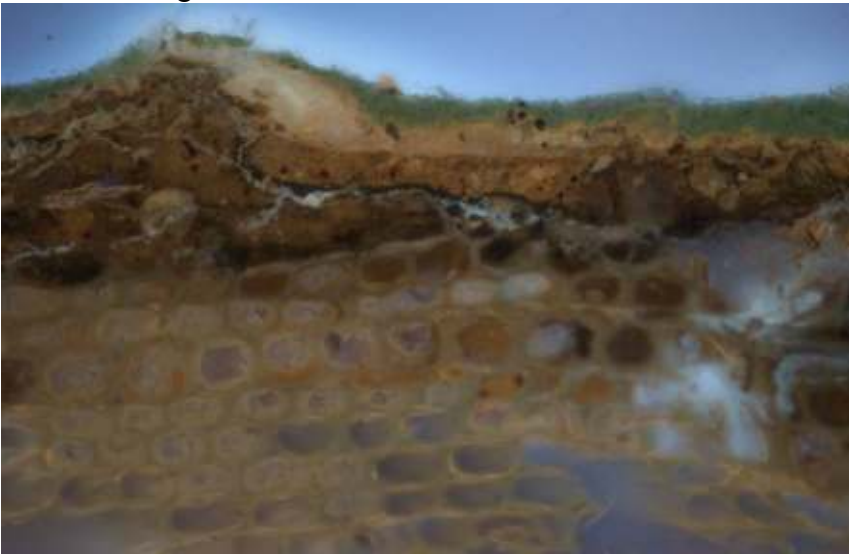
Ultraviolet Light 200X

Sample 14. Drawing Room. North wall, door in NW corner, upper left corner of upper left panel, room-side surface.

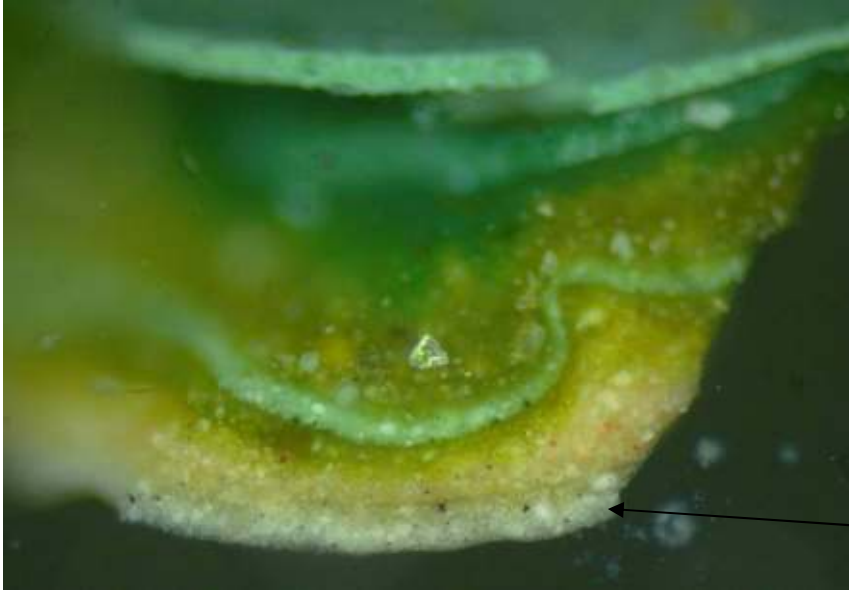
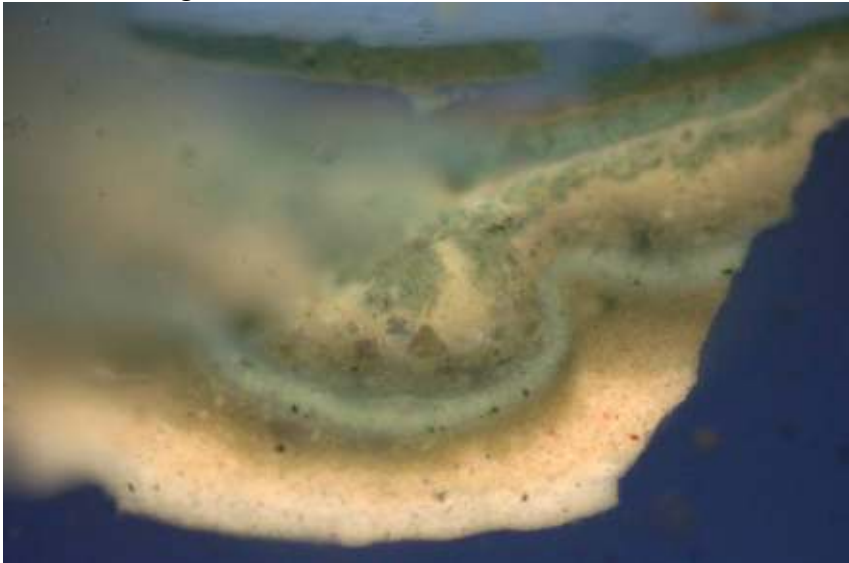
Sample 15. Drawing Room. South wall, door architrave, left side, about 3-feet up from floor.

Original blue-gray paint

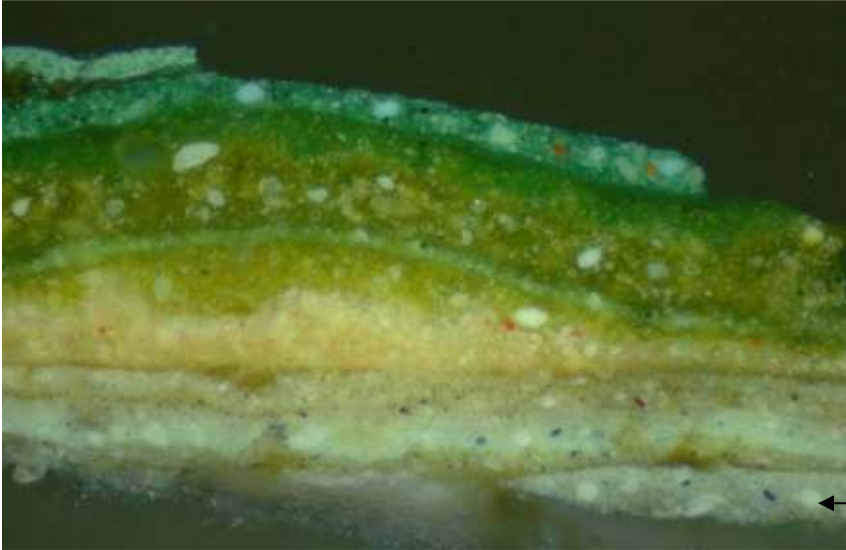
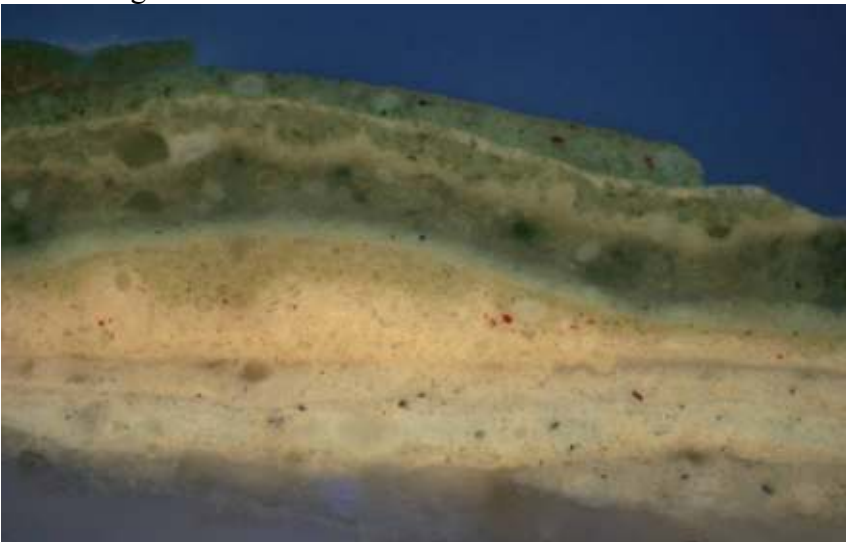
Sample 18. Drawing Room. North wall, architrave for door, left side, just below top of wainscoting.

First blue-gray paint

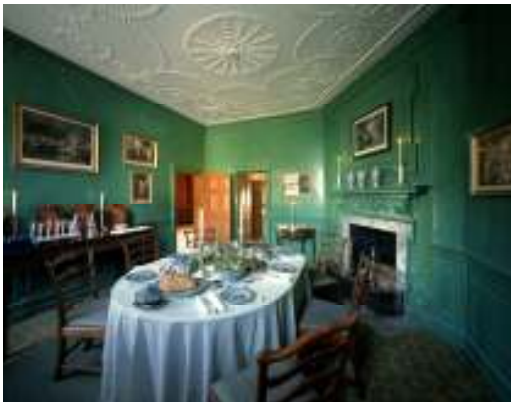
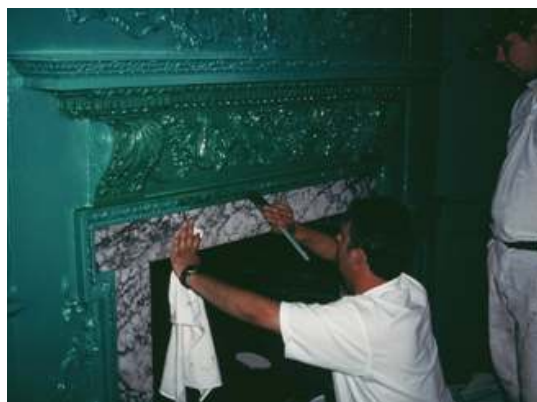
This layer was matched by eye under a color-controlled light source at 30X magnification. The appearance of this layer and binding media reactions suggest it was glossy. The overall appearance of this paint layer is similar to the replicated verdigris-copal resin varnish glaze over a green base coat in the Small Dining Room at Mount Vernon (see below) which was replicated 2001 based on paint analysis conducted by the author.
